Texas Commission on Environmental Quality
Investigation Report
CITY OF GARLAND
CN600328694

CHARLES M HINTON JR REGIONAL LANDFILL
RN103049490

Investigation # 788725

Investigation Type : Compliance Investigation

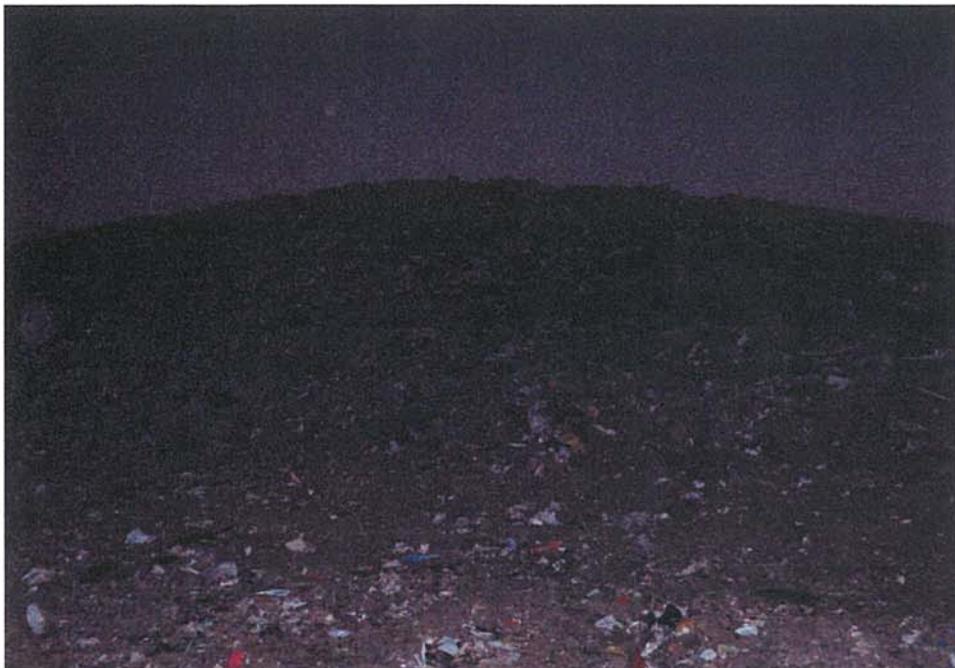
Photograph 1: Taken on 11/04/09

Location: Cell 2 KK, LL

Notes: Note visible MSW material exposed. The investigators observed the working face before incoming loads arrived.

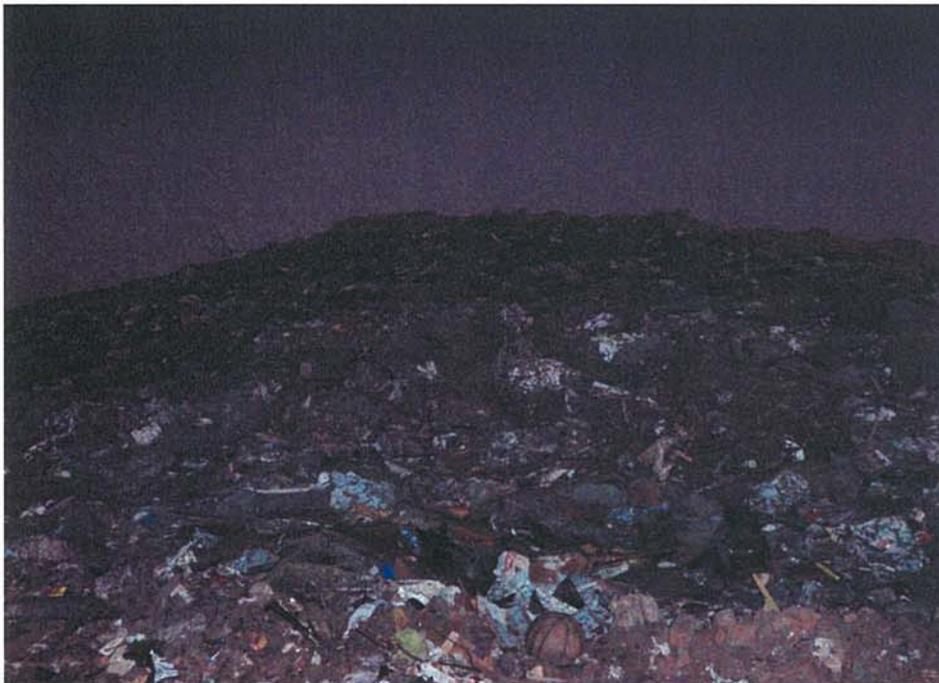
Photograph 2: Taken on 11/04/09

Location: Cell 2 KK, LL

Notes: Note visible MSW material exposed. The investigators observed the working face before incoming loads arrived.

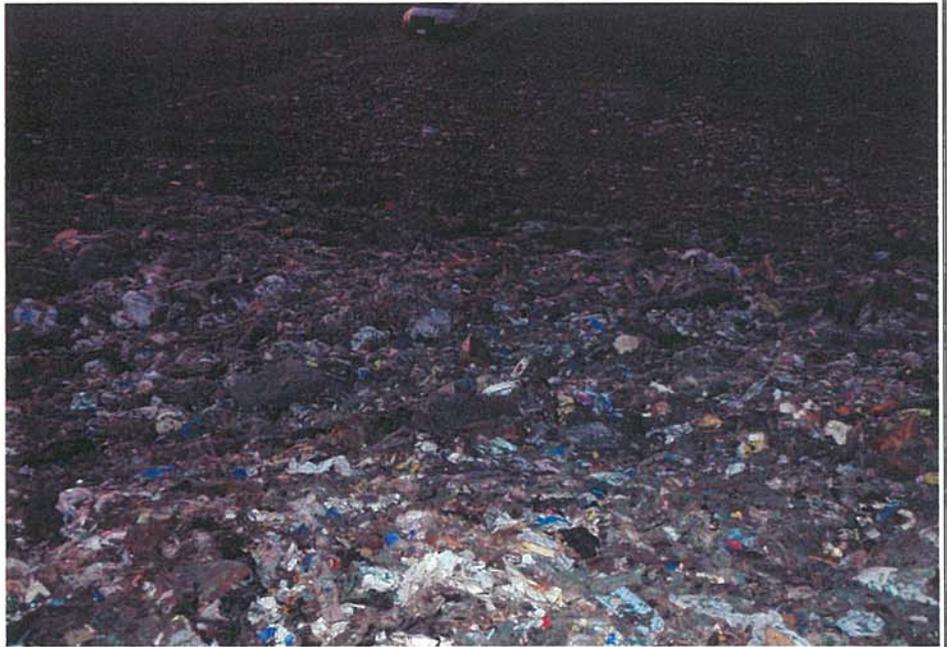
Photograph 3: Taken on 11/04/09

Location: Cell 2 KK, LL

Notes: Note visible MSW material exposed. The investigators observed the working face before incoming loads arrived. This view is facing down the working face slope.

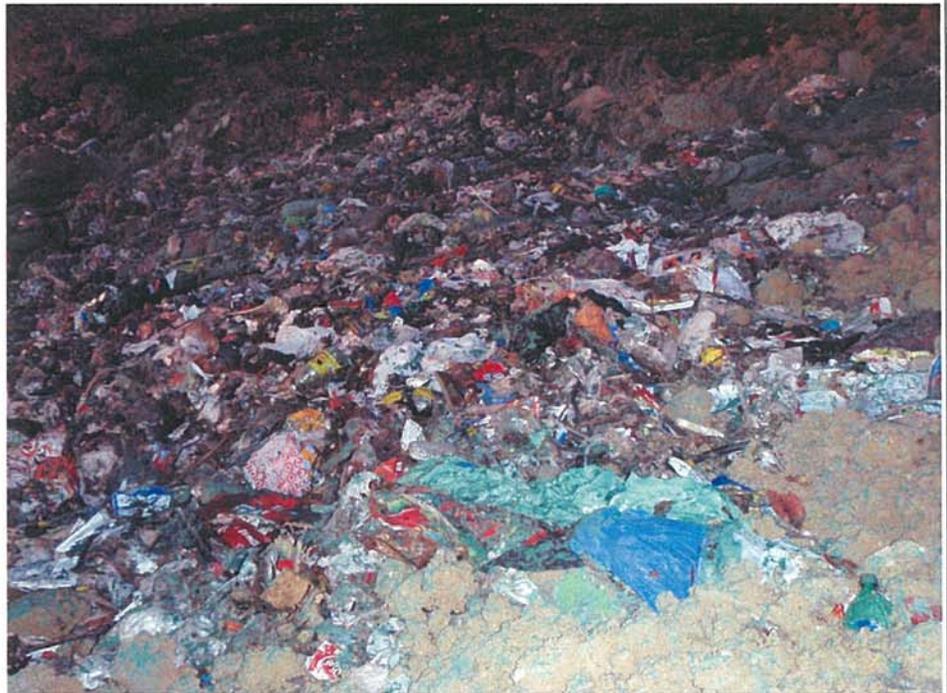
Photograph 4: Taken on 11/04/09

Location: Cell 2 KK, LL

Notes: Note visible MSW material exposed. The investigators observed the working face before incoming loads arrived. This view is facing down the working face slope.

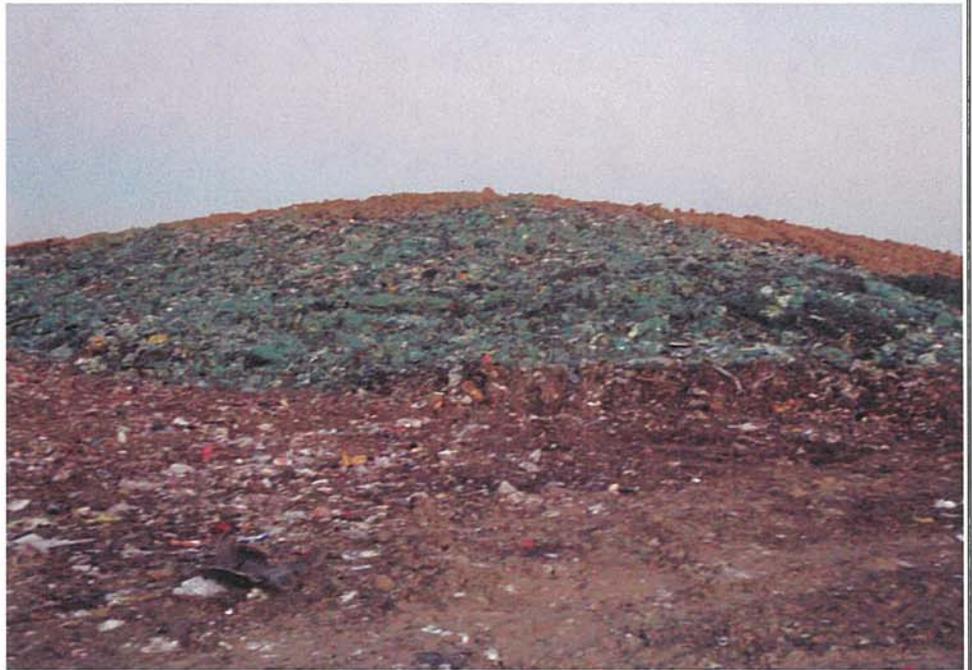
Photograph 5: Taken on 11/04/09

At the time of the investigation on November 04, 2009, it appeared that the required minimum of a ¼ inch of the alternative daily cover was not sufficiently applied over the entire working face. Mr. Cooper observed a sufficient amount of garbage that was exposed at the active working face. The regulated entity is requested to ensure that a minimum of ¼ inch alternative daily cover is applied throughout the entire working face to meet appropriate compliance with permit requirements.

Location: Cell 2 KK, LL

Notes: It appears that the ADC was applied; however MSW material is exposed.

At the time of the investigation, the writer observed and noted that the regulated entity had not sufficiently applied ADC throughout the active working face. The writer recommended the regulated entity to apply the ADC from different angles for adequate daily cover coverage of its active working face. A TCEQ General Compliance letter including one additional issue was transmitted to the regulated entity in January 2010.

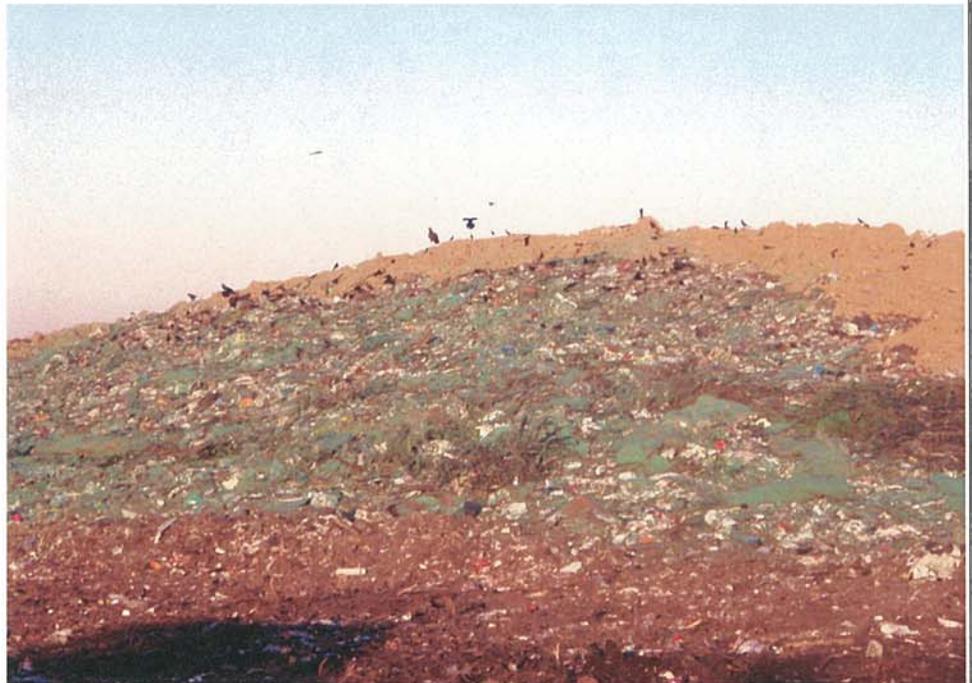
Photograph 6: Taken on 11/04/09

Review of the facility's daily log indicated that the facility utilized both soil and ADC prior to the on-site investigation. The writer also reviewed a daily inspection sheet from the facility that indicated that the ADC was controlling vectors, fires, odors, and windblown litter (See Attachment 4). At the time of the investigation, the writer observed that migrating birds did not scavenge through the applied BioCover working face (See Attachment 2, Photograph 6).

Location: Cell 2 KK, LL

Notes: It appears that the ADC was applied; however MSW material is exposed.

Note that birds was not salvaging through the applied ADC.
